BELZONA PROTECTS CRUDE OIL STORAGE TANK

Tank Farm - Mexico

Exterior coating of 1000-barrel crude oil storage tank.

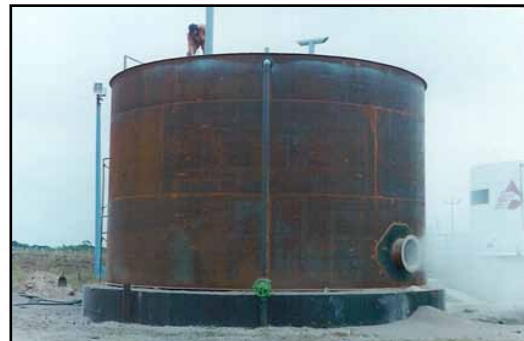
Due to the tank farm's proximity to the coast, a host of components, including abrasion from the sand, salt air, contamination from residual sour gas and other chemical components, contributed to the accelerated erosion/corrosion of the exterior of the storage tank.

1. Overall condition of the tank before the application of the Belzona coating system.
2. Grit blasting taking place.
3. Application of Belzona® 6111 using spray equipment.
4. View of the tank once the Belzona coating system had been applied.
