CO₂ ABSORPTION TOWER GETS BELZONA PROTECTION

Refinery - Argentina

CO₂ Absorption Tower

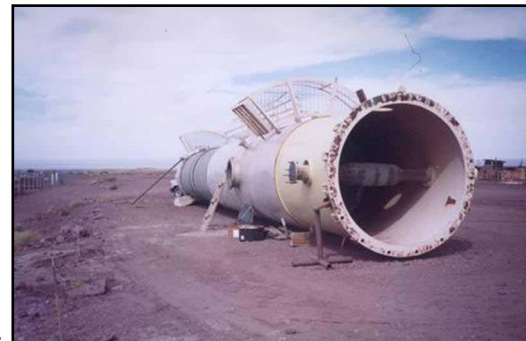
Severe corrosion on the interior of the tower due to the presence of MDEA and subsequent production of carbonic acid.

1. View of the tower before being taken into a shop for the application.
2. A high level of quality control was implemented during the surface preparation phase of the application, as well as with the rest of the job.
3. View of the final application. The Belzona® 1391 was applied in two coats. Sandblasting was carried out in between the first and second coat.
