BELZONA REPAIR TO STONE CRUSHER SHAFT

Cement plant in Bulgaria

May & June 2003

Shaft of stone crusher.

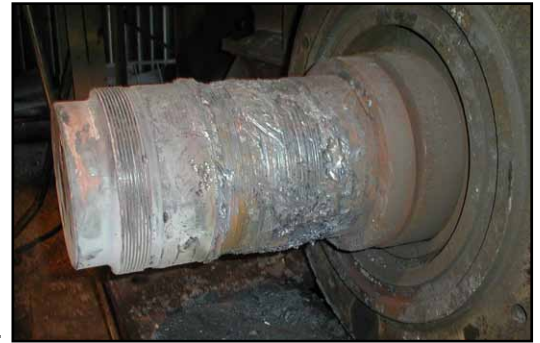
Severe wear on these 230mm diameter shafts caused by extreme loads, vibration and abrasion from dust leads to bearing failure.

1. Severely damaged shaft
2. Former in place and Belzona® 1321 injected
3. Former removed and ready for re-assembly of bearing
