BELZONA PROTECTS COOLING WATER SPOOLS

Power station - Ireland

Main cooling water intake pipework.

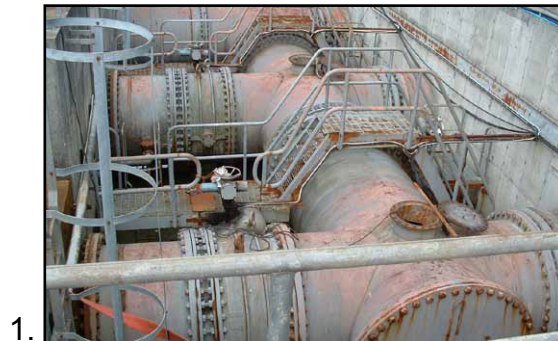
1. General view of the spools
2. Degree of original erosion clearly evident
3. Application underway
4. Completed application

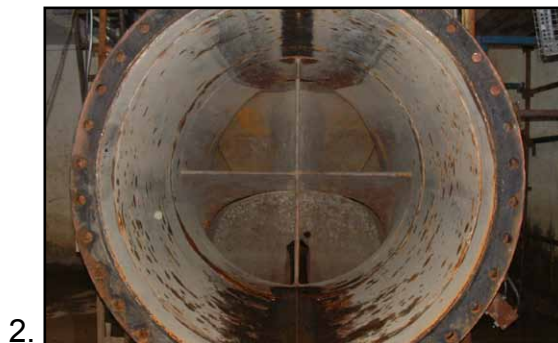
Previous coating was badly damaged allowing severe erosion-corrosion on pipework internals.

Some spools were so badly corroded that they had to be replaced or sleeved. The Belzona® 1341 coating will prevent future costly replacement becoming necessary.
