## BELZONA REPAIR TO OIL COOLER

Power Station in Sri Lanka

Thrust bearing oil cooler from turbine

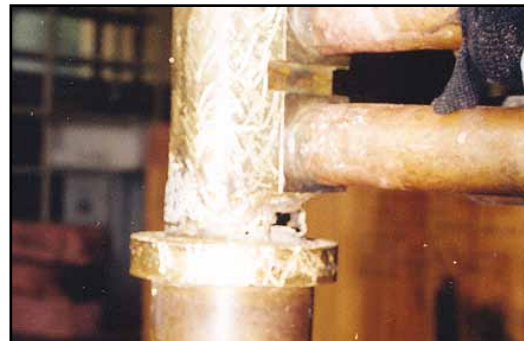
The unit was severely damaged and leaking as a result of bimetallic corrosion.

1. Corroded unit with holes clearly visible
2. Belzona® 1111 being used to repair holed and corroded areas
3. Belzona® 1321 being applied to protect unit
4. Completed application being pressure tested
