BELZONA REPAIRS TO RUBBER LINED CONDENSER

Power station - Ireland

Rubber lined water boxes of condensers.

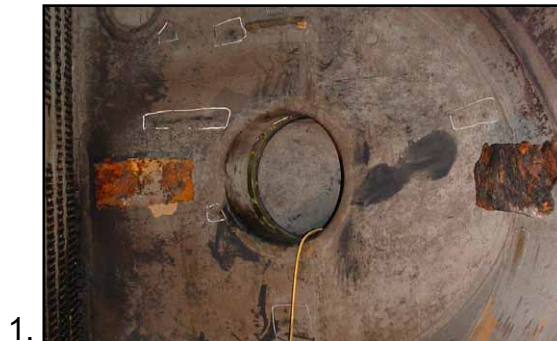
Spark testing of rubber lining highlighted several defects requiring repair.

1. Damaged areas of lining identified and marked ready for repair.
2. The repair area masked off to ensure application is kept within prepared area. Conditioner being applied.
3. One of the many local repairs completed.

Application was carried out in accordance with Belzona Know-How System Leaflet HEX-4. Spark testing identified defects which were then locally repaired.
