## BELZONA PROTECTS SLUG CATCHERS AGAINST EROSION AND CORROSION

Slug catchers destined for gas processing plant

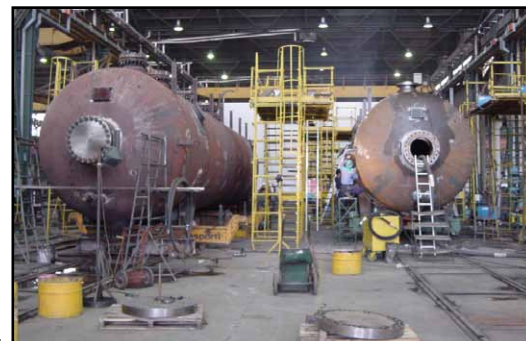
1. Two of the slug catchers ready for internal coating.
2. The Belzona® 1391 being applied.
3. Sponge testing the Belzona® 1391 to ensure no application defects were present in the coating.

Vessels were to be put into operation at 90 °C and 70 bar pressure in a mixture of hydrocarbons and water. Belzona was applied to the bottom third of the vessels where the water gathers and causes corrosion.
