BELZONA REPAIRS MASSIVE FAILURE OF KILN SUPPORT CASINGS

Cement works in Egypt

Rotary kiln used in cement production

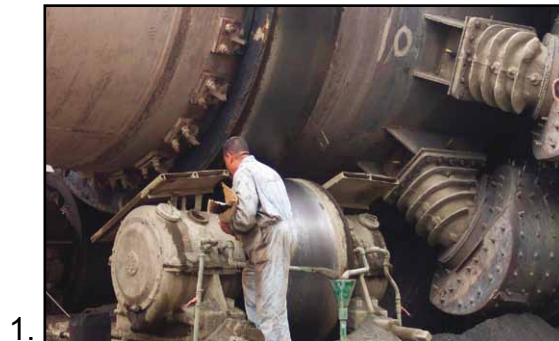
1. General view of the trunnion supports
2. The shattered casings
3. One of the fabricated strengthening plates in position
4. Belzona® 1111 used to bond and seal the cracked casing

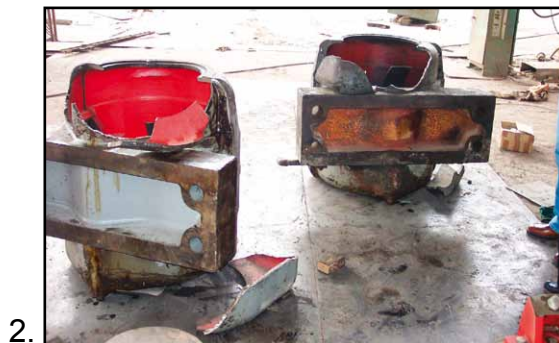
Casings on trunnion supports shattered due to the breakage of the roller neck.
