BELZONA EMERGENCY LEAK SEALING: THREE HOURS LATER - IT'S READY

Fertilizer producer in Egypt

Natural gas separator operating at 43 bar pressure

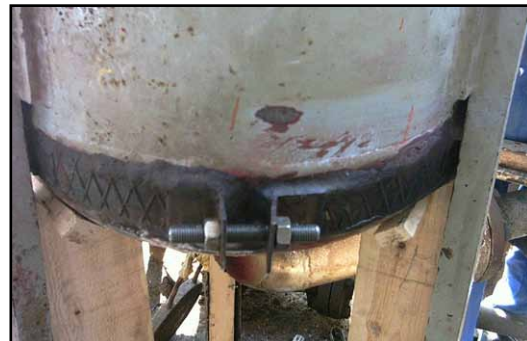
Corrosion of vessel had caused leak.

Belzona® 1291 was initially used in conjunction with a metal clamp to stem the leak before applying Belzona® 1111 with Belzona® 9341 (Reinforcement Tape) to complete the application. Repair completed quickly and safely without heat so preventing the need for a major plant shut-down.

1. Belzona® 1291 used in conjunction with metal clamp to initially stem the leak
2. Belzona® 1111 plus Belzona® 9341 (Reinforcement Tape) applied to strengthen the repair
3. Repair completed in 3 hours
