## BELZONA REPAIRS TO FERRY MAIN ENGINE

Main diesel engine from ferry

Severe cavitation and corrosion in cylinder block bores in way of cylinder liner lands.

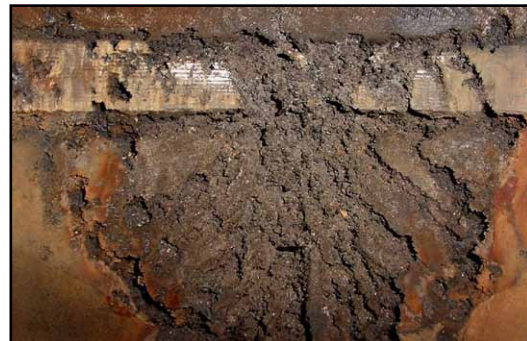
1. The severity of the cavitation clearly evident
2. Surface preparation underway
3. The Belzona® 1311 being formed to profile
4. Completed application with Belzona® 1391 applied to top water gallery
