'ISOLATION' PROBLEMS SOLVED WITH BELZONA

Isolation spools for titanium cooler

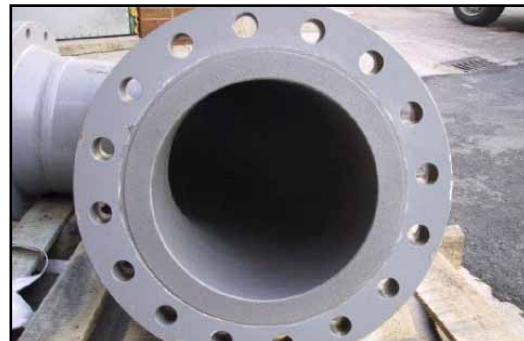
1. Pipespool grit blasted and ready for coating
2. Following coating and removal of the former ready for dressing
3. Post pressure test awaiting despatch to customer

Belzona® 1391 and Belzona® 1591 were applied to the internal surface of each of the spools in accordance with Belzona Know-How System Leaflet VPF-2. To eliminate the possibility of defects, which would allow very rapid corrosion, the coating materials were applied as two coat systems. Immediately following application of the second coat, the flange faces were reformed according to Belzona Know-How System Leaflet VPF-13.
