## SOAP POWDER CAN'T WASH BELZONA AWAY!

Manufacturer of washing powder in Italy

Soap Mixer

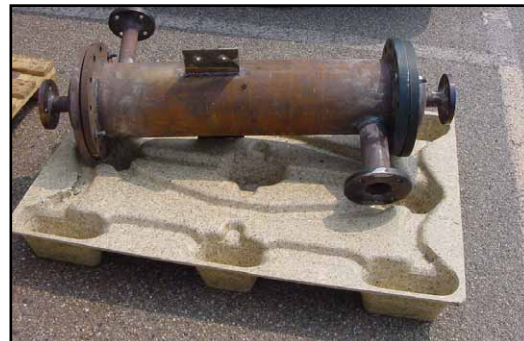
Corrosion from the soap powder and water mixture damages the housing and rotating elements of the mixer.

1. The mixer as it arrives
2. The coated rotating elements
3. The mixer end covers coated
4. The mixer body coated
