## BELZONA FLANGE REPAIR SYSTEM SAVES MONEY

Flange faces on 16", 300lb crude oil transfer hoses

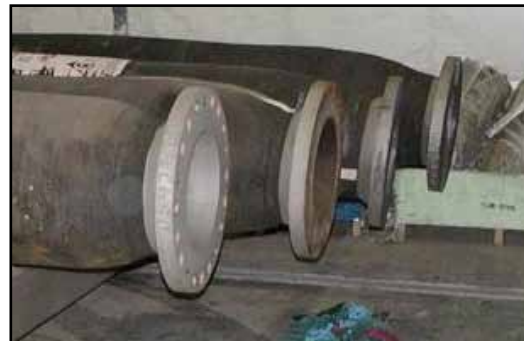
External corrosion on the flange faces had resulted in the hoses not being able to seal correctly and as a result were considered no longer fit for purpose.

1. Four floating hoses awaiting repair
2. Close up showing corrosion damage and plugs and shims fitted into place
3. Completed application, awaiting dressing down and pressure testing

The four hoses shown in the picture represent a cost to the customer if replaced of approximately £100,000 (\$160,000). All four hoses were effectively covered and tested to 18 bar according to International (OCIMF 1991) and Dunlop Oil & Marine Test Guidelines. This was done for a fraction of the cost of replacement hoses.
