WATERPROOFING CHIME ANGLE WITH BELZONA

Power Plant - Texas USA

Tank Chime Angle

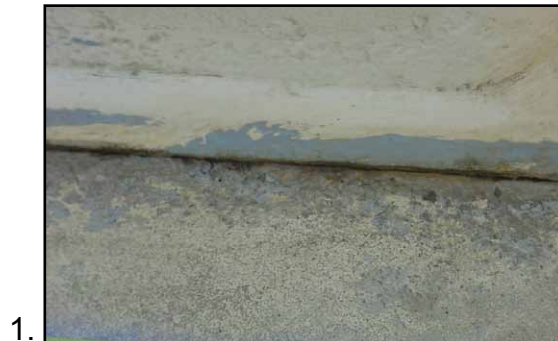
Corrosion was occurring on steel/concrete interface of wastewater tank and pad.

1. Close look at the problem area
2. Prepared surface taped off
3. Application completed
