BELZONA SOLUTIONS FOR LEAKS

Animal food manufacturing - Missouri, USA

Filter drain - below grade.

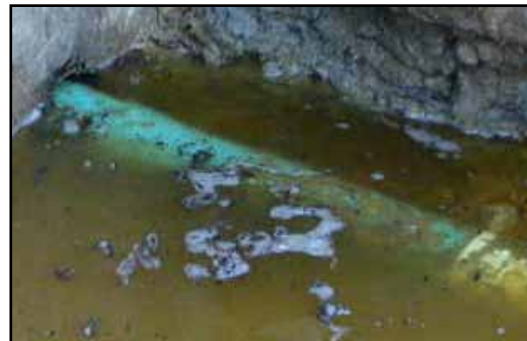
Filler used between the drain pipe and the wall when constructed was allowing water to seep through the one inch gap around the pipe and collect underground. A \$10,000 fine from environmental concerns was on the horizon.

1. Visible leak
2. Leak sealing with Belzona® 4211 in process
3. External heat was applied to decrease curing time and ensure the area was dry
4. Finishing the application
