BELZONA SEAL SOLUTIONS FOR GENERATORS

Power station on the St. Lawrence Seaway - Canada

Generator housing

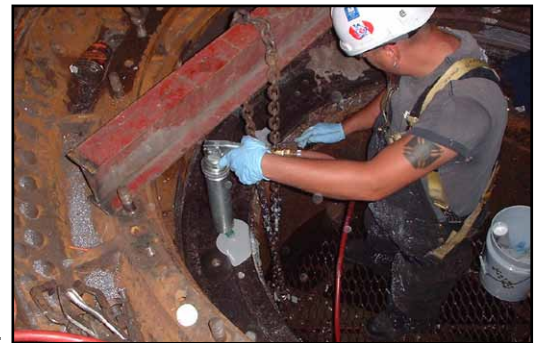
1. Traversing the St. Lawrence Seaway takes some 8.5 sailing days
2. Slurry mix of Belzona Systems being injected into the voids
3. Formers were fabricated to rebuild the inside seat area
4. Inside seat reformed

A slurry mix was made of Belzona® 4111 and Belzona® 4151 so it could be injected through the steel in concrete voids. Following this, Belzona® 1311 was used to provide an even seat for the generator to set upon.
