## KITCHEN SAFETY IMPROVED THANKS TO BELZONA

School in UK

Floors in kitchen area

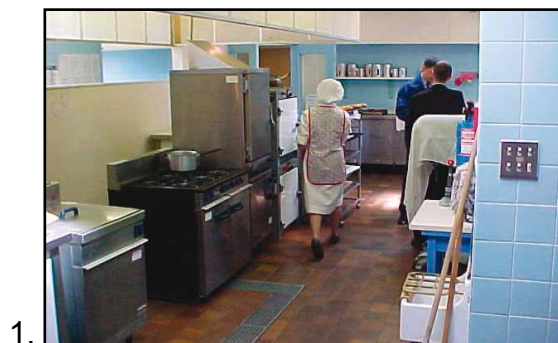
Routine health inspection had highlighted hygiene and safety problems with the floor area necessitating refurbishment before the school re-opened.

1. Kitchen area prior to the Belzona application
2. Wash area prior to the Belzona application
3. Belzona® 5231 applied
4. Application completed

Two coats of Belzona® 5231 were applied after thoroughly cleaning and grit blasting the existing tiled surface.

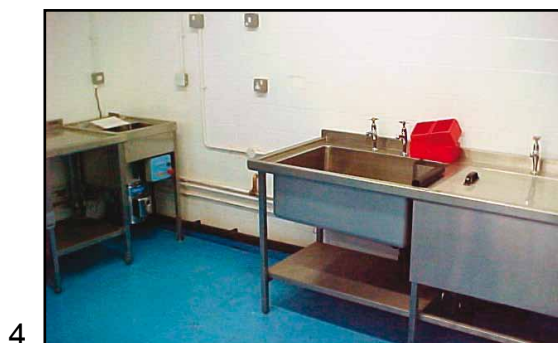
Belzona® 5231 created a hygienic, seamless floor surface with the right degree of non-slip to provide safe footing for the kitchen staff. The application was completed smoothly in the short holiday period during which the school was closed.
