INSPECTION PIT SAFETY IMPROVED WITH BELZONA

Military installation - UK

Workshop floors including inspection pit

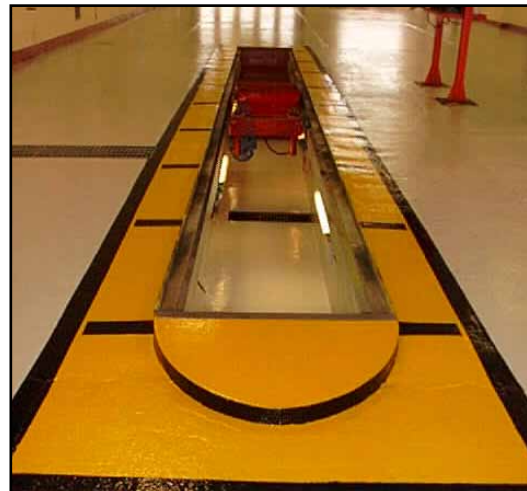
1. Overview of the inspection pit, following application.
2. Belzona systems improve safety on steps too.

After scabbling the concrete and planing rough areas a two-coat system of Belzona® 5231 was applied to the workshop floor and inspection pit. An additional strip of Belzona® 4411 grip system was applied to step nosings to provide additional grip and safety.
