BELZONA PROTECTS PUMP PLINTH

Manufacturer of television tubes in Germany.

Pump Plinth

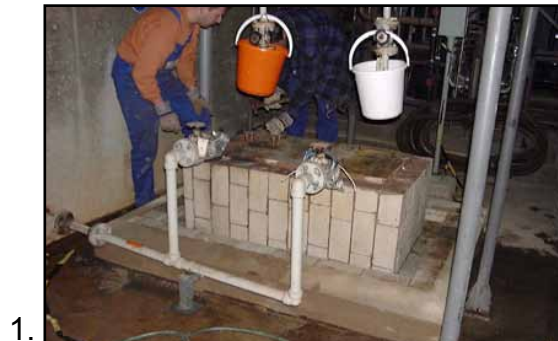
98% Sulphuric acid leaking from the pump had damaged the grout between the acid resistant tiles and attacked the concrete beneath.

1. The damaged pump plinth
2. Rebuilt with Belzona® 4111
3. And coated with Belzona® 4341
