BELZONA® 3211 (LAGSEAL) IN TOUGH ENVIRONMENT - 2ND TIME AROUND

Power plant in Texas, USA

Coating on insulated caustic storage tank

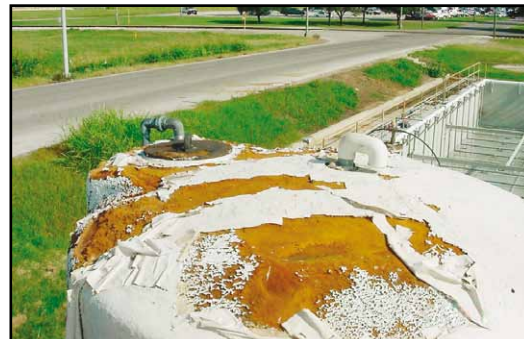
1. View from acid tank
2. Surface preparation
3. Belzona® 3211 applied

Belzona® 3211 held up well (eight years) in this tough environment. Fumes from neighboring acid tank condensed on a tank, causing rapid deterioration of the previous coatings.
