BELZONA STOPS WINDOW LEAKS

Community College, St. Charles, Missouri USA

August 2005

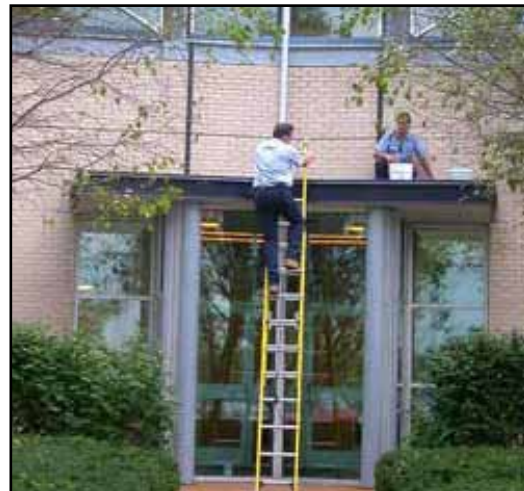
The bottoms of the windows had almost imperceptible openings allowing wind blown water to enter and travel to the entry canopy staining the ceiling tile.

1. View of windows above entry canopy.
2. Close up of the problem and start of the repair.
3. Finished repair.
