BELZONA SAVES ANIMAL FEED MANUFACTURER

Animal food manufacturer - Missouri USA

Crankshaft was scored due to debris and low oil levels in the sump.

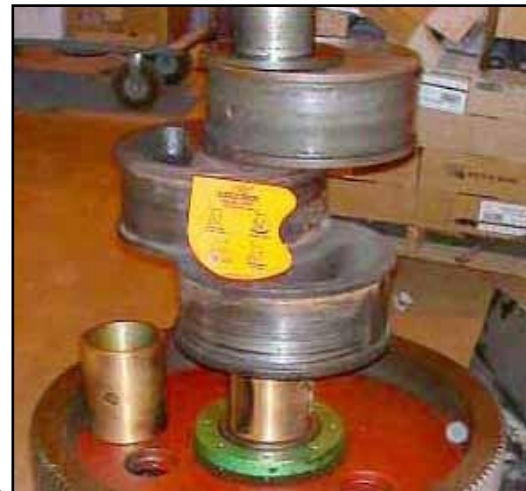
1. Crankshaft
2. Close up of scored & repaired bottom journal
3. Another close up of the repair

Application carried out in accordance with Belzona System Leaflet MPT-9. Belzona® 1131 was hand applied to the scored journal and subsequently hand finished with fine emery.
