BELZONA REBUILDS BEARING SURFACE ON PAPER MACHINE DRIVE

Pulp & Paper Operation, BC, Canada

Bearing fit on paper machine drive

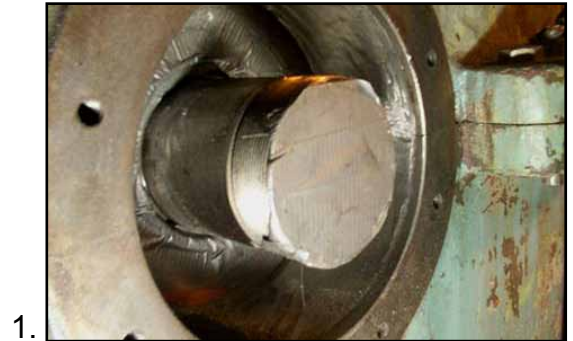
1. The bearing fit area ground to provide a rough surface and degreased with Belzona® 9111
2. The mold was positioned carefully before injecting Belzona® 1321 Ceramic S Metal
3. The mold removed, revealing a perfectly formed new bearing surface

Application carried out in accordance with Belzona Know-How System Leaflet MPT-7.
