## BELZONA REBUILDS DAMAGED DRYER CAN JOURNAL IN 5 HOURS

Pulp & Paper Operation, BC, Canada

Damaged dryer can journal

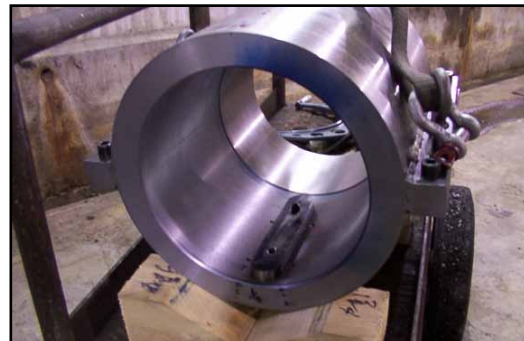
1. View of completed mold with new keyway fitted
2. Grinding of the damaged journal underway
3. The mold has been fitted and the Belzona® 1391 injected - see excess coming out of vent holes on top of mold.
4. Mold removed revealing rebuilt journal
