NOZZLE REPAIR WITH BELZONA INSERTS

North Sea Platform

Small bore nozzles in sea water Hyperfilter units.

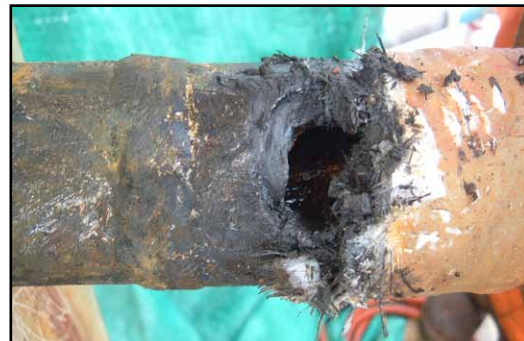
Current repairs to corrosion damage in small bore pipe work not working. They were failing quickly due to the inability to prepare the nozzle internal correctly and apply the coating pinhole free.

1. Typical small bore nozzle damage (note this cannot be repaired with an insert!)
2. Typical Belzona® 1111 insert
3. Insert bonded into the nozzle from inside vessel and surrounding coating repaired
4. Insert bonded into position from the flange
