BELZONA REPAIRS NATURAL GAS VALVE

Oil and gas production company, Egypt

Natural gas valve

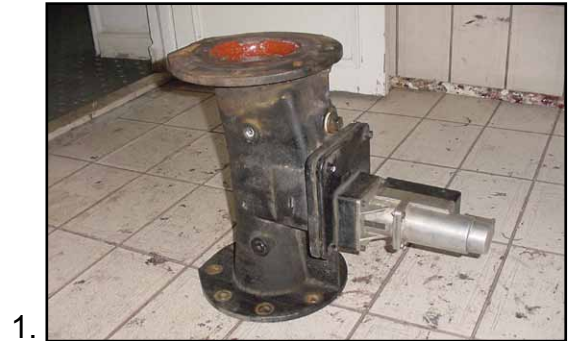
1. General view of the valve.
2. Traditional welding failed causing more leakage.
3. Surface preparation.
4. Application completed.

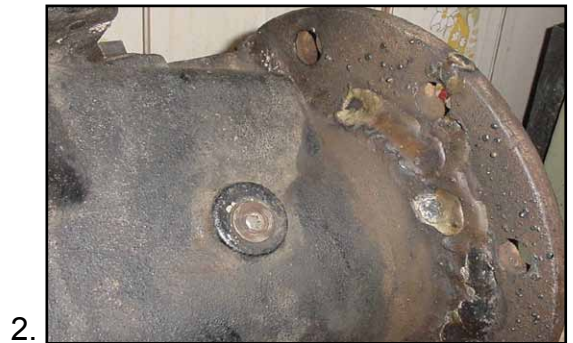
Gas leaks had been worsened by traditional weld repairs.
