BELZONA SAVES OIL COOLER FROM SCRAP HEAP

Coal fired power station - Germany

Oil cooler in power station

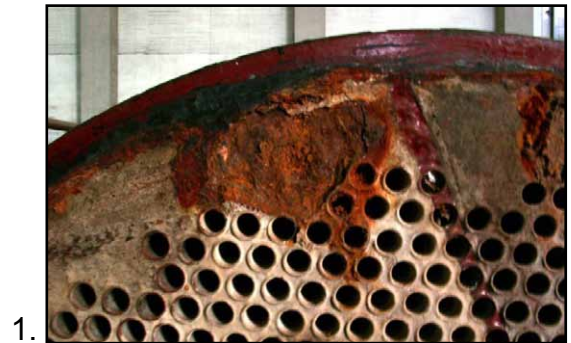
After 40 years in service the oil coolers were suffering from severe corrosion.

1. Corroded tubesheet.
2. Completed tubesheet.
3. Tubesheet at opposite end.
4. Close-up.

The corrosion damage was rebuilt with Belzona® 1311 and coated with Belzona® 1321 in accordance with Belzona System Leaflets HEX-1 and HEX-3.
