BELZONA CASTING IMPERFECTION REPAIR

Pump manufacturing company, Egypt

Cast pump casing

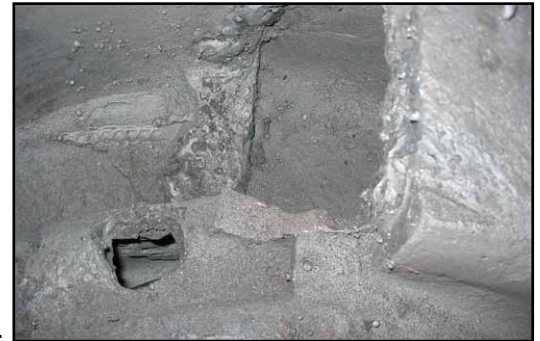
Defects in casting caused holes and cracks in the pump.

1. Casting imperfections in the pump.
2. Preparing the cracks in the pump.
3. Wetting out the surface with Belzona® 1311.
4. Pump was repaired and protected.
