BELZONA® 1341 STANDS THE TEST OF TIME AT IRRIGATION PLANT

Irrigation Plant, North Queensland, Australia

Impellor from an irrigation pump.

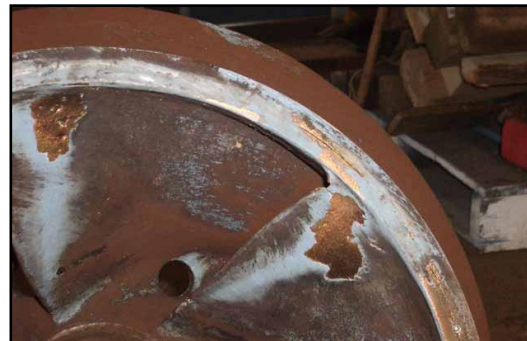
1.

Due to general erosion / corrosion to this impellor, the customer requested sacrificial coating to protect the equipment.

PICTURES

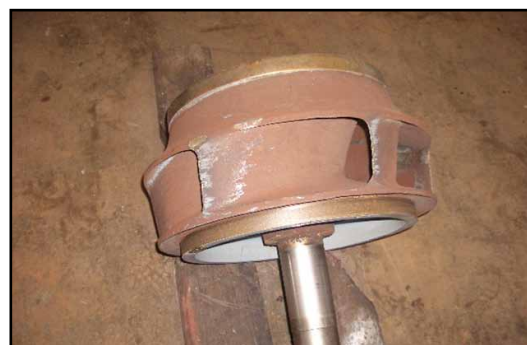
3.

Recent inspection of the impellor revealed, that after 12 years of hard work following the Belzona® 1341 application, wear is minimal. Although there is a brown deposit left on the impellor from the river, it is very easily removed with a paper towel.
