BELZONA CATION LINING REPAIR

Oil production company , Egypt.

Cation exchange vessel in the water treatment station.

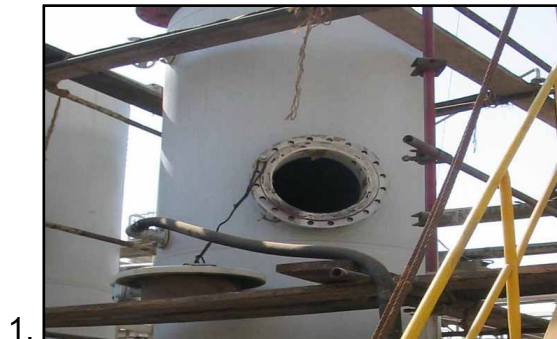
1. General view of the Cation.
2. The perished areas inside the cation.
3. Surface preparation.
4. Belzona® 2121 applied.

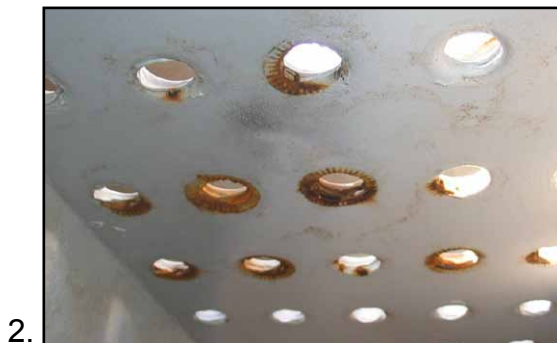
The rubber lining of the cation had deteriorated and had been lost in many places.
