## BELZONA KEEPS COOLING WATER PUMP RUNNING

Coal power plant in Macedonia.

Two cooling water pump impellers

Cavitation-erosion damage on the impellers

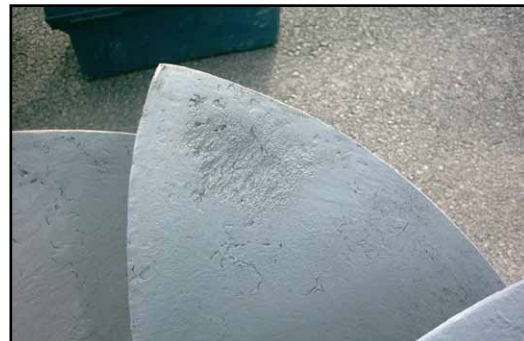
1. Eroded pump blades.
2. Filled pump blades with Belzona® 1311.
3. Finishing with Belzona® 1321.
