BELZONA KEEPS WHEAT REFINER RUNNING

Wheat mill in Macedonia.

Drive shaft on Wheat refiner

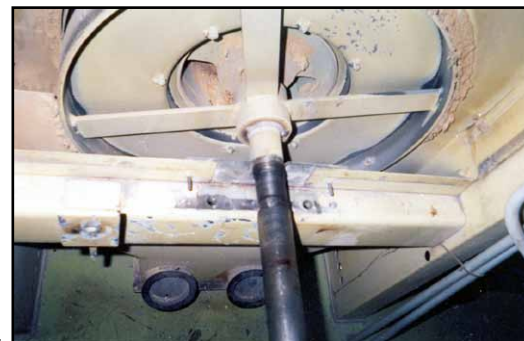
Bearing failure damaged the shaft.

1. The damage on the shaft is evident.
2. The former was used to rebuild the shaft.
3. The former was removed after Belzona® 1221 had cured.
4. Bearing re-assembled.
