BELZONA REPAIRS HEAT EXCHANGER END COVERS

Cement Works, Usje, Macedonia

Heat Exchanger End Covers

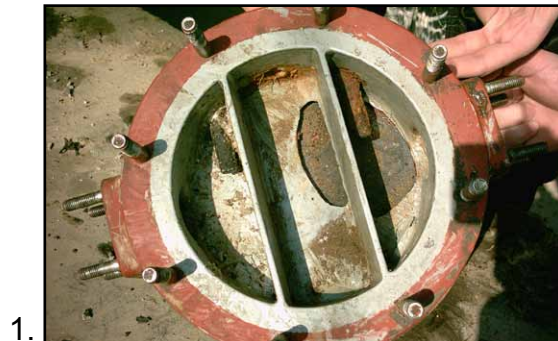
Holes and cracks had appeared on the end covers due to freezing water.

1. Damaged End Cover
2. Surface Preparation
3. Belzona® 1111 Rebuild
4. Finished Application With Belzona® 1321 Coating
