BELZONA SEPERATES DISSIMILAR METAL PIPES

Offshore platform, UK

Pipe linings and flanges.

Galvanic corrosion between dissimilar pipe sections.

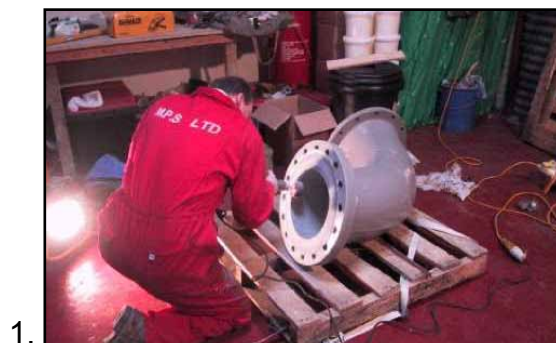
1. Surface Preparation.
2. Pipe masked up.
3. Finished Application.
