## MUFF COUPLING REPAIR WITH BELZONA

Muff coupling (The part that joins two parts of propeller shaft together)

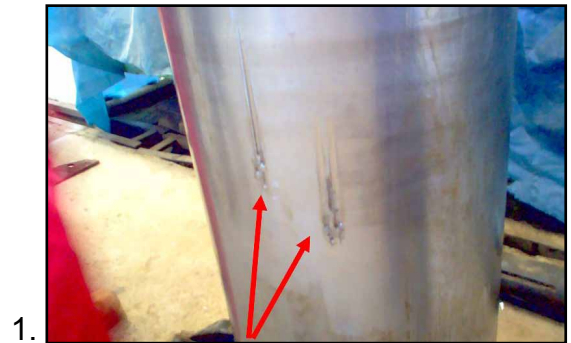
Scratches on inner and outer surfaces of coupling.

1. Scratches on the inner part of the Muff Coupling.
2. Filling the scratches with Belzona® 1111.
3. Belzona® 1111 applied to the coupling.
4. Application completed.
