BELZONA PROVIDES LONG TERM PROTECTION IN HIGH TEMPERATURE SULPHUR

Oil Refinery, United Kingdom

Sulphur pit internal equipment

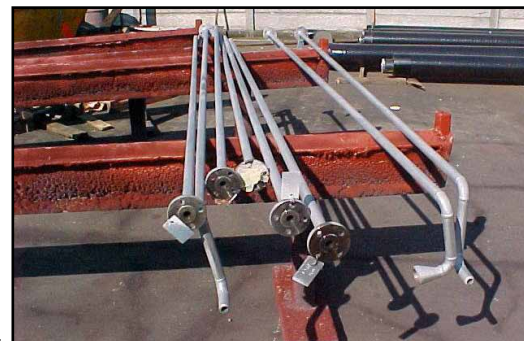
1. Pipes ready for application.
2. Brush application of Belzona® 1591.
3. Coated pipes.
