BELZONA GRIP SYSTEM HELPS POWER PLANT

Coal Fired Power Plant, Macedonia

Conveyor belt drive roller

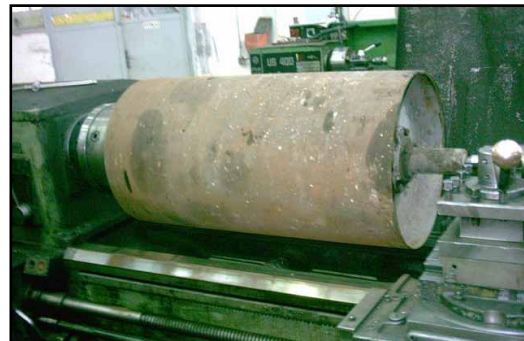
1.

The original rubber lagging had worn away and the loss in friction was allowing the belt to slip and lose efficiency.
