## BELZONA EXTENDS THE LIFE OF ID FANS

Pulp and Paper Operation - Port Alberni, British Columbia, Canada

ID Fan housing

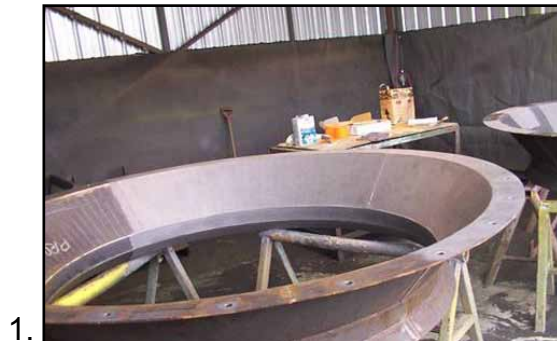
1. Two new housings awaiting grit blasting.
2. Application of Belzona® 1812 in progress.
3. Application to first housing complete with second partially completed.
