BELZONA PROTECTS LP FLARE DRUM

Low Pressure Flare Drum with Design conditions -46°C/+99°C and 5 bar pressure.

Failure of existing Glass Flake lining, leading to corrosion

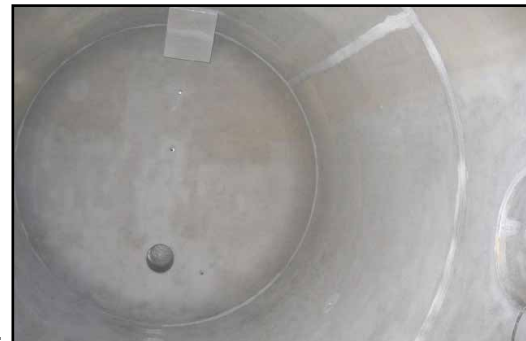
1. Blast preparation and stripe coat complete
2. Spray application and repairs complete
3. Inspection after 12 months service
4. LP Flare drum in service

Belzona 1521 was applied in accordance with a modified Belzona Know-How System Leaflet TCC-5.

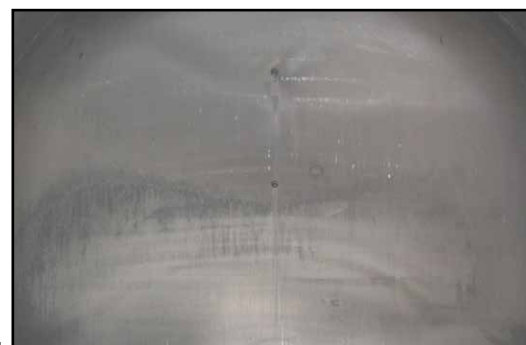
3.

Belzona 1521 was selected based upon Belzonas track record with its coatings in this service, and the speed of application possible with a spray applied system. In fact this 65m² application was completed, including removal of the existing coating, application, testing and cure in 5 days, reducing downtime for the client. Inspected in 2014 the lining was found to be in excellent condition. Local repairs to mechanical damage carried out before returning vessel to service.
