BELZONA REPAIRS FRANCIS TURBINE WICKET GATES

Hydroelectric Power Plant, Czech Republic

Francis Turbine Wicket Gate

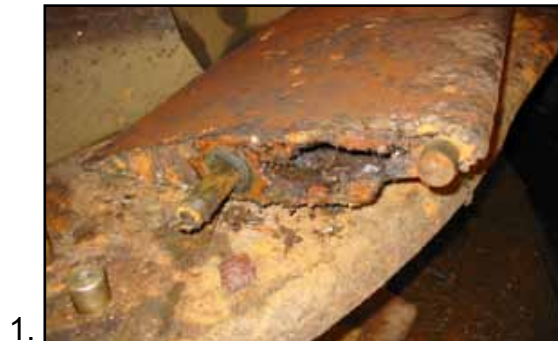
Impact by debris in the water in conjunction with erosion and corrosion had left this turbine in a terrible state of repair and in need of replacement

1. Damaged Wicket Gate Blade
2. Blade After Grit Blasting
3. Blade After Rebuilding With Belzona® 1111
4. Blade After Coating With Belzona® 1341
