BELZONA GIVES A FRANCIS TURBINE A NEW LEASE OF LIFE

Hydroelectric Power Plant, Czech Republic

Francis turbine runner

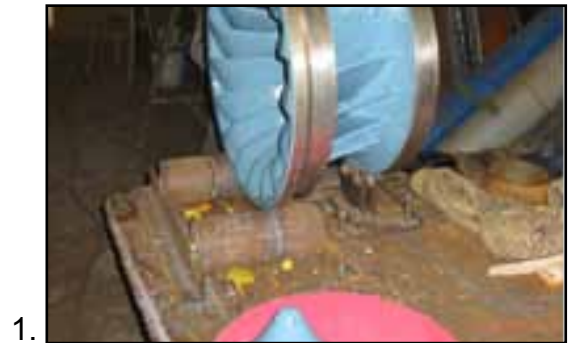
The working surfaces on the runner had suffered from erosion causing the turbine to lose efficiency.

1. The Turbine runner
2. After application
3. Coated with Belzona® 1341
