## RESTORATION OF BRONZE IMPELLER WITH BELZONA

AEP/PSO - Oolagah, OK

Cooling water pump impeller.

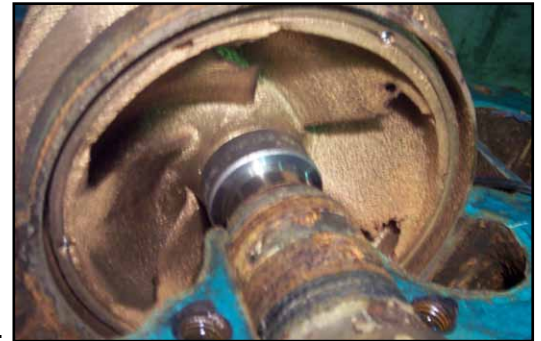
This pump impeller, 1 of 4, normally running 24/7 had eroded to the point of replacement.

1. First inspection showing extent of erosion damage
2. Mesh in place and rebuild proceeding
3. Grinding to contour
4. Rebuilt and ready for service

Application was carried out in accordance with Belzona Know-How System Leaflet CEP-1, CEP-3 and CEP-5. Stainless Steel mesh used to reform vanes. After rebuilding, grinding to original profiles and coating, impeller was re-balanced.
