CLASSIC PUMP REFURBISHMENT WITH BELZONA

Pump Housing

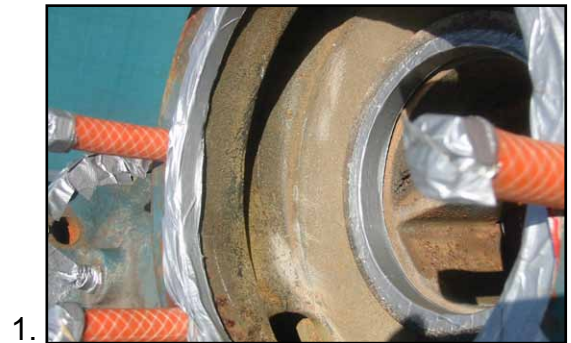
Erosion/corrosion from constant water flow within the pump caused erosion in critical parts of the housing.

1. Rebuilding profiles underway
2. Another view of profiles
3. Completed application

Belzona® 1111 (Super Metal)

Belzona® 1321 (Ceramic S-Metal)

The application was carried out in accordance with Belzona Know-How System Leaflet CEP-2 & CEP-5.
