PUMP SUMP PROTECTION WITH BELZONA ON OIL TANKER

Oil Tanker owner, Palermo, Italy

February 2006

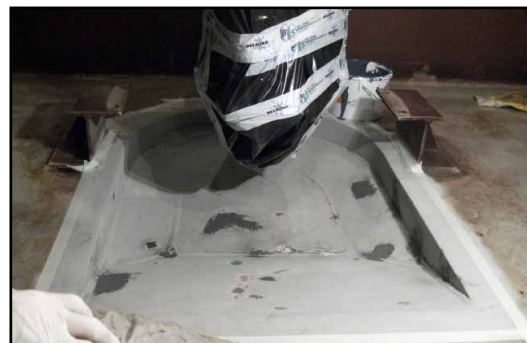
Erosion/Corrosion due to the constant liquid flow over the sump during cargo transfer.

1. The tanker in dock.
2. Sump after blasting.
3. Sump coated with Belzona® 1391.
4. Completing the application.

Belzona® 1391 (Ceramic HT Metal)

Application was carried out in accordance with Belzona Know-How System Leaflet TCC-5.
