BELZONA REBUILDS AND PROTECTS KORT NOZZLES

MV HAIDA MONARCH - Vancouver, BC. Canada

Kort nozzles of large self propelled marine log loader

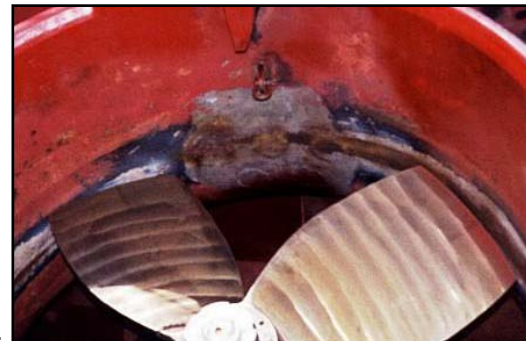
Erosion-Corrosion of inner circumference of kort nozzles.

1. View of port side nozzle showing erosion pattern after three years service.
2. View of starboard side nozzle after three years of service.
3. Re-application of Belzona® 1341 to complete nozzle after welding had been completed to close various cracks.
