BELZONA REBUILDS AND PROTECTS A BULB TURBINE BODY

Hydroelectric Power Plant, Drome, France

Bulb Turbine

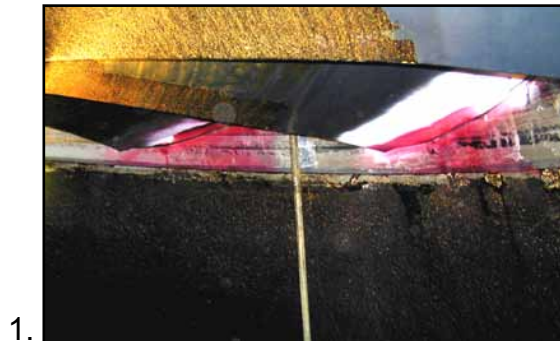
1. Application situation
2. The problem
3. The solution

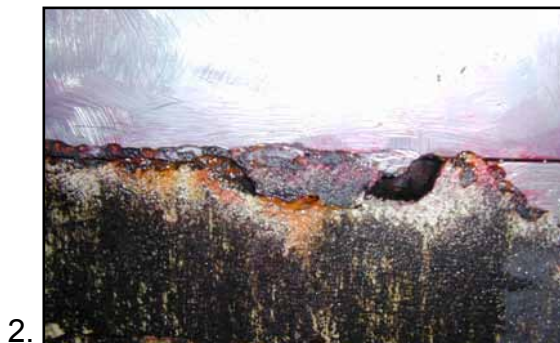
Severe galvanic corrosion between inox and steel leading to water infiltration.
