BELZONA REPAIRS A HYDROELECTRIC TURBINE

Hydroelectric Power Plant, France

Francis Turbine

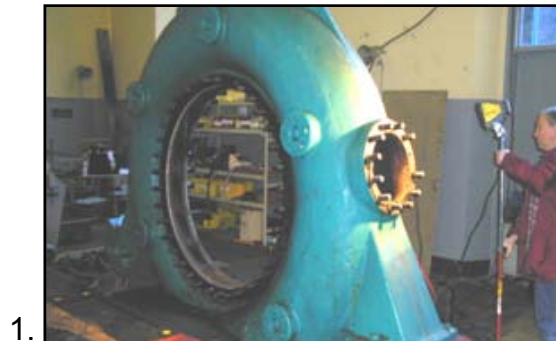
1. The Francis turbine
2. Inside the turbine
3. The extent of the damage
4. The completed application

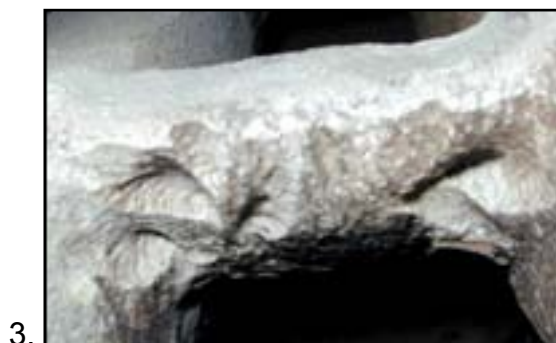
Erosion, corrosion and cavitation of the stay vanes and the casing had induced vibration into the turbine and was also making the turbine run inefficiently.
