## BELZONA KEEPS ENTRANCE WAY NICE AND SAFE

Theme Centre, Doncaster, UK

Timber Decking

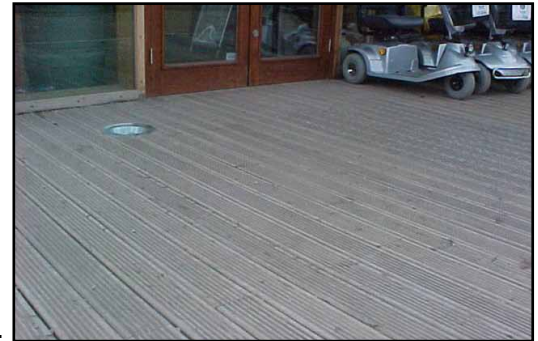
Slippage problem, especially on the main entrance of the building. The client had tried unsuccessfully to combat the problem by nailing chicken wire to the timber decking, which caused extra trip hazards.

1. Slippage problem area.
2. After masking 2 out of 6 grooves, Belzona® 5811 was mixed with 50% aggregate applied.
3. Masking being removed from completed application.
