BELZONAS OPTIMIZED BEARING INSTALLATION

Container Ship Rudder Bearings

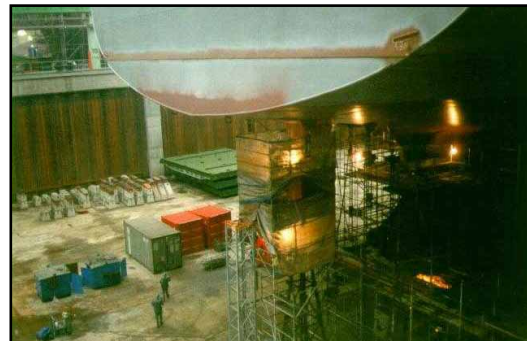
1. Aft end of containership
2. Positioning and sealing of lower annulus
3. Injection of Belzona® 1321
4. Vent ports installed to ensure void free application
