## BELZONA SOLVES HOLED TANK & HANDRAIL PROBLEM

Chemical Manufacturer (Chromium), UK

Holed chemical tank & corroded handrail support.

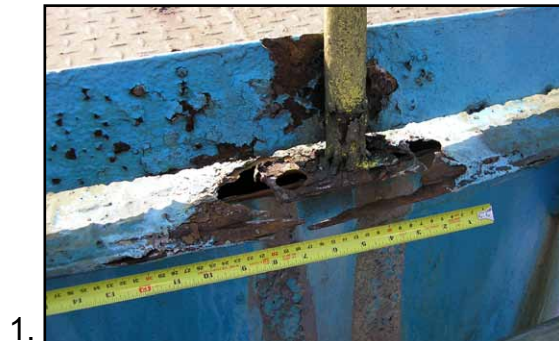
General corrosion on this old chemical tank had left a hole at the top under a handrail support.

1. View of corroded area.
2. Surface preparation ongoing.
3. Rebuilding with Belzona® 1111.
4. The completed repair.
